Intel[®] Mobile Pentium[®] III Processor Specification Update

Release Date: April 2000

Order Number: 245306-006

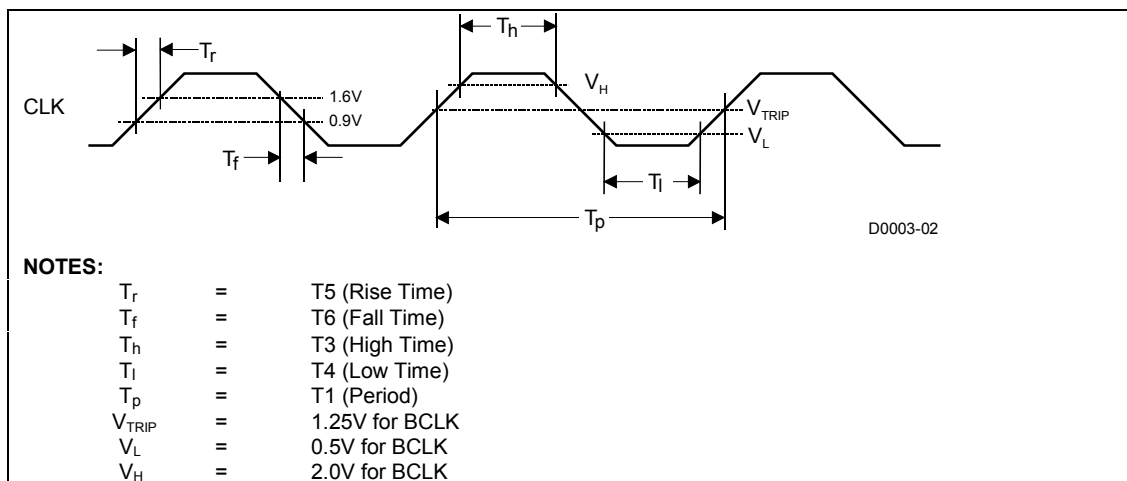
Figure 7. BCLK Timing Waveform

1. All AC timings for GTL+ and CMOS signals are referenced to the BCLK rising edge at 1.25V. All CMOS signals are referenced at 0.75V.
2. The BCLK period allows a +0.5 ns tolerance for clock driver variation.
3. Not 100% tested. Specified by design/characterization.
4. Measured on the rising edge of adjacent BCLKs at 1.25V. The jitter present must be accounted for as a component of BCLK skew between devices.

| Symbol | Parameter | Min | Typ | Max | Unit | Figure | Notes |
|---|---|---|---|---|---|---|---|
| T1 | BCLK Period | | 10 | | ns | Figure 7 | Note 2 |
| T3 | BCLK High Time | 2.70 | | | ns | Figure 7 | at >2.0V |
| T4 | BCLK Low Time | 2.45 | | | ns | Figure 7 | at <0.5V |
| T5 | BCLK Rise Time | 0.175 | | 0.875 | ns | Figure 7 | (0.9V – 1.6V) |
| T6 | BCLK Fall Time | 0.175 | | 0.875 | ns | Figure 7 | (1.6V – 0.9V) |
